# BELZONA ADDS SAFETY TO SWIMMING POOL STAIRS

**Industry:** Buildings & Structures  
**Application:** FPA-Floor Problem Areas  
**Substrate:** Stainless steel  
**Products:** \* Belzona 1321 (Ceramic S Metal) ,

**Customer Location:** Swimming Pool, Nova Scotia, Canada  
**Application Date:** September 2009

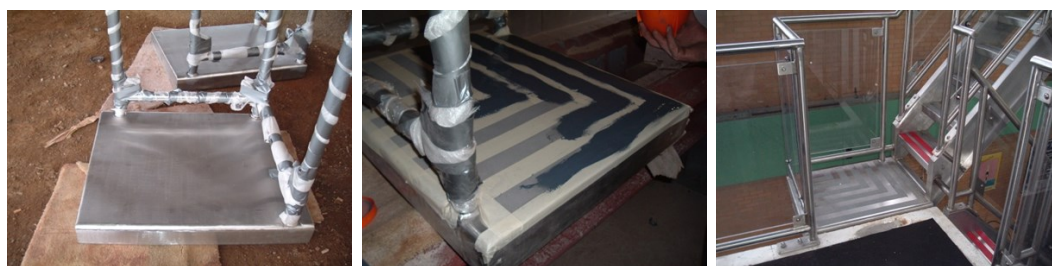
- \* The surfaces of the stainless steel landings were grit blasted to ensure good adhesion to the metal surface ,
- \* The area was masked off in a chevron style pattern to ensure adequate safety for the multi directional traffic the landing would be subjected to ,
- \* The completed application installed at the base of the diving tower. ,

The swimming pool facility was upgrading the access stairs to the diving tower.

Application was carried out in accordance with a modified version of Belzona Know-How System Leaflet FPA-8.
