BELZONA STOPS DAMAGE FROM PITTED CHOCKS

Industry: Marine
Application: SOS-Ships and Offshore Structures

Customer Location: Oil tanker, Pacific Northwest, U.S.A.
Application Date: 1998

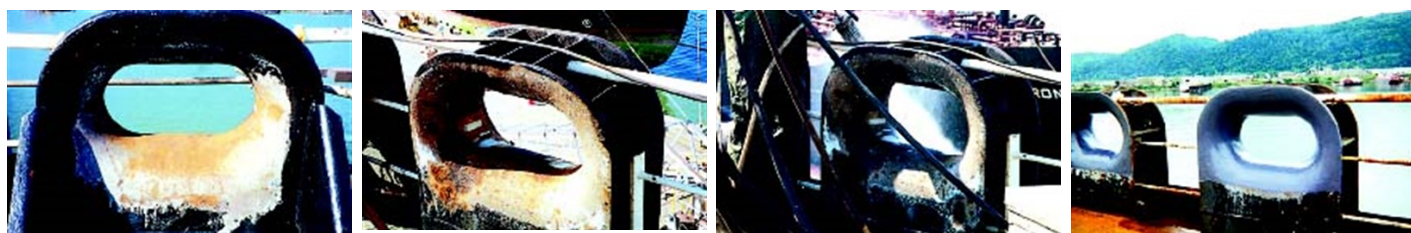
Photograph Descriptions

Chocks pitting and the roughness was destroying the hawsers.

- * Close-up of chock with peeling paint. ,
- * View of chock showing extensive pitting. ,
- * Surface preparation in progress. ,
- * Finished application. ,

Ship's mooring lines (hawsers) are very expensive. The steel casting for the chocks became pitted from the salt. This caused jagged edges which wore out the hawsers prematurely.

Application was carried out out in accordance with a modified version of Belzona Know-How Leaflet SOS-19.
