# BELZONA STOPS DAMAGE FROM PITTED CHOCKS

Industry: *Marine*  
Application: *SOS-Ships and Offshore Structures*

Customer Location: *Oil tanker, Pacific Northwest, U.S.A.*  
Application Date: *1998*

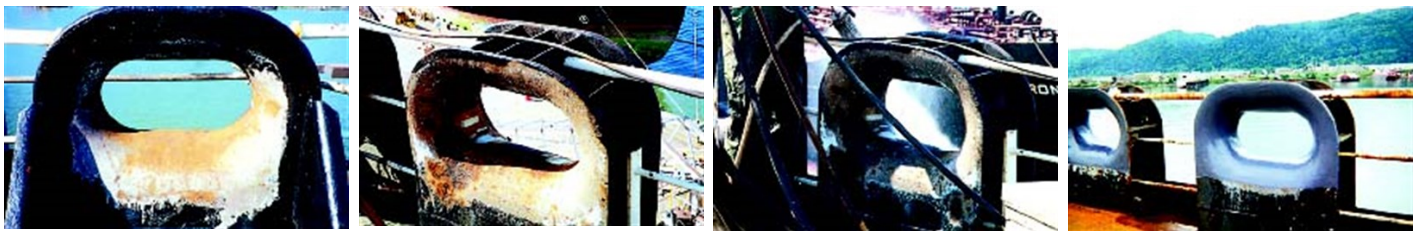
*Chocks pitting and the roughness was destroying the hawsers.*

- \* Close-up of chock with peeling paint. ,
- \* View of chock showing extensive pitting. ,
- \* Surface preparation in progress. ,
- \* Finished application. ,

Ship's mooring lines (hawsers) are very expensive. The steel casting for the chocks became pitted from the salt. This caused jagged edges which wore out the hawsers prematurely.

Application was carried out in accordance with a modified version of Belzona Know-How Leaflet SOS-19.
