# Belzona Protects Ships Rudder From Cavitation

ID: 4803

Application: SOS-Ships and Offshore Structures

Application Date: October 2013

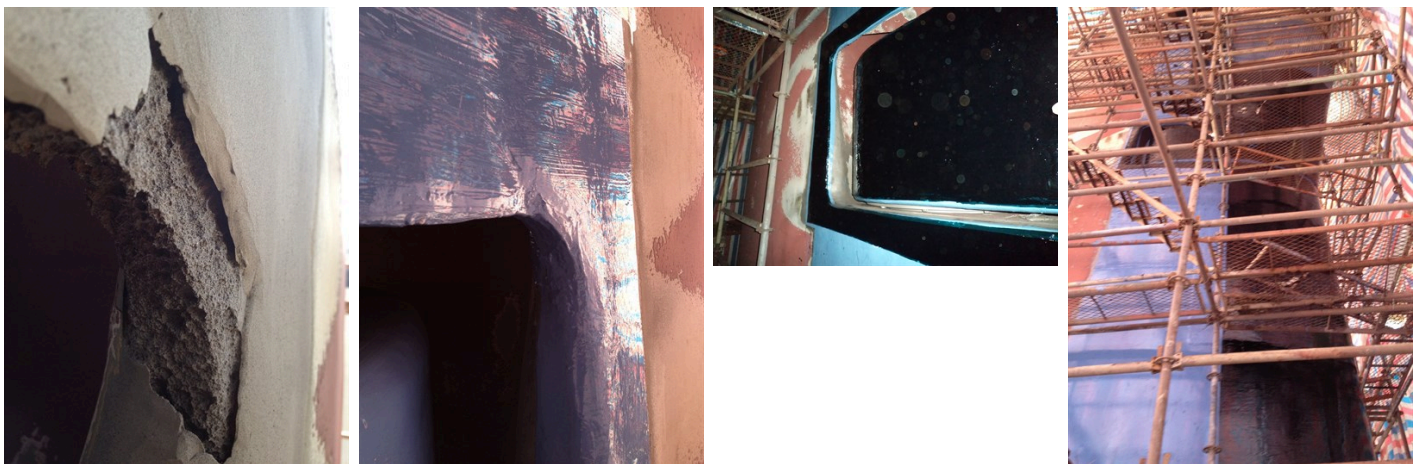
*Due to the nature of the shape of a rudder, coupled with disturbed water flowing from the propellor, cavitation damage was aparent on the rudder. Previous attempts to resolve the situation involved overlaying with stainless steel. This led to galvanic corrosion in places and did not stop the cavitation.*

\* Photo 1 - Overlaid stainless steel corroding and cavitating Photo 2 - Damaged area rebuilt and coated Photo 3 - Full coating system applied Photo 4 - Final View ,

Following surface preparation, All pitting was filled and rebuilt with Belzona 1311. Belzona 1341 was then applied as a 1 coat system straight over the Belzona 1311. Once the Belzona 1341 had cured, Belzona 2941 was applied to the areas where Belzona 2141 would be applied. Belzona 2141 was then applied in a 2 coat system with the top coat as black.

Previously stainless steel had been bonded over the mild steel rudder. This led to galvanic corrosion and also did not completely stop cavitation. Belzona were able to reclaim the corroded material and protect against the cavitation effects.
