BELZONA RINGS A TUNE

Industry: *Buildings & Structures*
Application: *RPA-Roof Problem Areas*
Substrate: *Concrete*
Products: ** Belzona® 3111 (Flexible Membrane) ,*

Customer Location: *University in Southern California, USA*
Application Date: *August 2004*

Problem
Roof leaks

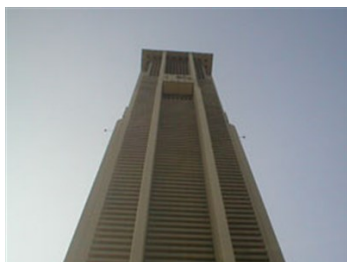
- * The bell tower ,
- * Leaks were allowing water to ingress the bells bellow ,
- * Problems clearly evident ,
- * Completed roof repair ,

161-foot bell tower
