# BELZONA KEEPS THE SHOT BLASTING GOING

**Industry:** Steel & Metal Processing  
**Application:** SHM-Solids Handling Machinery

**Customer Location:** Metal Foundry, Spokane, WA  
**Application Date:** February 2014

**Substrate:** Rubber conveyor belt  
**Products:** \* Belzona 2211 (MP Hi-Build Elastomer) Belzona 2911 (Elastomer QD Conditioner) Belzona 9341 (Reinforcing Sheet),

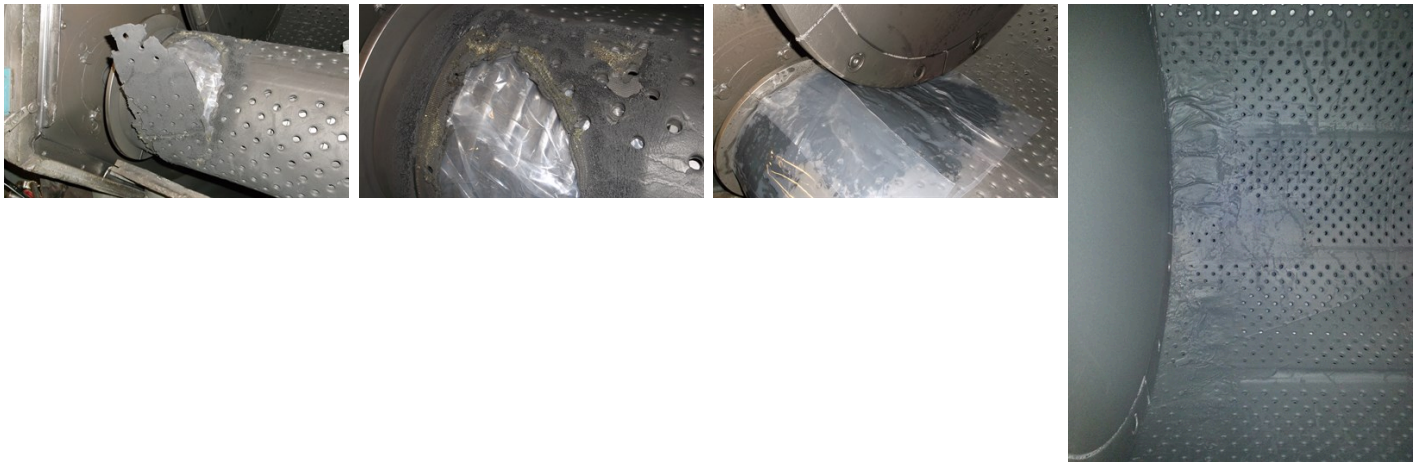
A metal part in the shot blaster caught the belt during operation and severely ripped the belt.

\* 1. Damaged belt 2. Roughened up area ready for application 3. Application completed and covered with plastic 4. 2 weeks later after use ,

Application was carried out in accordance with a modified Belzona Know How System Leaflet SHM-1. Guard plates were removed allowing for partial access to the complete area to be repaired. All loose material was cut away and the area prepared with a roughening brush. Plastic was slipped underneath the belt to prevent any attachment to the metal drive rollers. Belzona 2911 was applied. Then Belzona 2211 was applied in two layers with Belzona 9341 over the seam areas. The entire job was completed in three sections due to accessibility and covered with plastic so the belt could be moved to complete the application. A heat lamp was mounted to maintain optimum curing temperature.

A replacement belt costs over \$4000 and takes 3 days to be replaced. The company was in the middle of a major production order and did not have the ability to shut down for that length of time. This repair cost them \$500 and 24 hours of down time making this repair a big success.
