BELZONA RENUEVA UN TAMBOR MOTRIZ DEFORMADO

ID: 4848

Ubicación del cliente: Mina de carbón en Macedonia
Fecha de aplicación: Agosto 2002

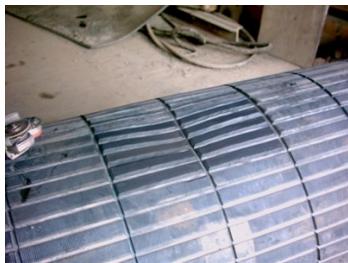
El tambor motriz tenía una cubierta de goma de 15 mm. La superficie del tambor se deformó mecánicamente durante su transporte con un montacargas.

- * Vista del tambor dañado ,
- * Preparación de la zona deformada ,
- * Aplicación concluida ,
