BELZONA BRINGS EXCAVATOR BACK TO SERVICE IN 1 DAY

Industry: Mining & Quarrying
Application: MPT-Mechanical Power Transmission

Customer Location: Salt mine, Germany.
Application Date: November 2009

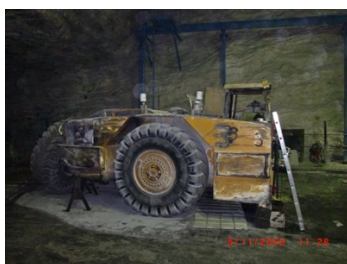
The severe conditions of corrosion and abrasion in the mine caused loss of metal in the articulated coupling, which resulted in reduced service life of the component.

- * Excavator shovel before the application ,
- * Injection of Belzona 1821 ,
- * Final application ,
- * Bearing back to service ,

Application was carried out in accordance with Belzona Know-How System Leaflet MPT-2. Belzona 1821 was injected into former to create required shaft diameter.
