BELZONA BRINGS EXCAVATOR BACK TO SERVICE IN 1 DAY

Industry: Mining & Quarrying
Application: MPT-Mechanical Power Transmission

Customer Location: Salt mine, Germany.
Application Date: November 2009

Substrate: Steel
Products: * Belzona 1821 (Fluid Metal),

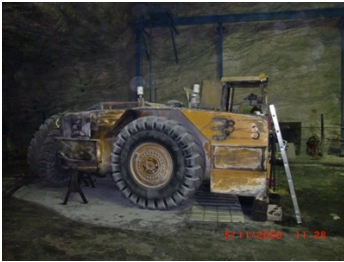
The severe conditions of corrosion and abrasion in the mine caused loss of metal in the articulated coupling, which resulted in reduced service life of the component.

- * Excavator shovel before the application ,
- * Injection of Belzona 1821 ,
- * Final application ,
- * Bearing back to service ,
