# BELZONA EROSION CORROSION PROTECTION APPLIED BY SPRAY

ID: 4871

Oxygenation vessel on offshore oil and gas platform

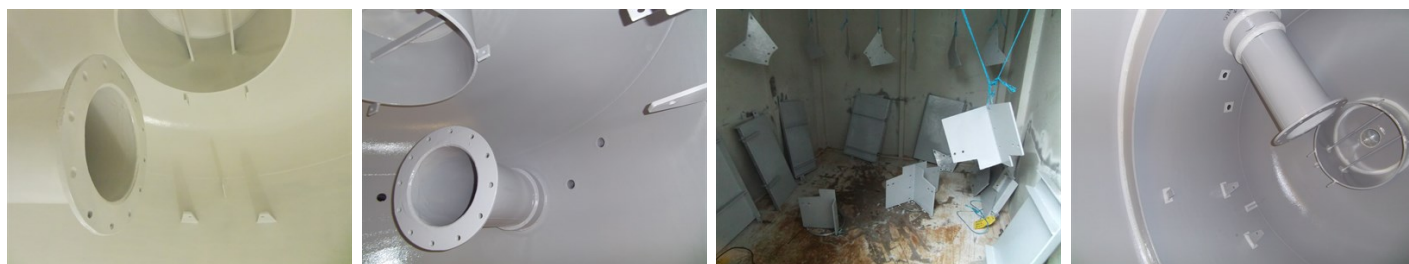
## Photograph Descriptions

Erosion and corrosion attack on the internals of the vessel resulted in the requirement for a fast applied lining which would resist further attack.

\* 1. Application of the first coat of Belzona 1331 (white) 2. Application of the second coat of Belzona 1331 (grey) 3. Internal furniture and brackets were coated separately 4. Finished coating with detailed areas completed by hand ,

Application was carried out in accordance with Belzona System Leaflet TCC-5. Following thorough surface preparation by grit blasting, Belzona 1111 was applied to fair off welds and in fill areas which had suffered from pitting. Belzona 1331 was then applied as a two-coat system by heated airless spray to provide overall erosion corrosion protection.
