MARINE EXHAUST SYSTEM INTERNALLY PROTECTED WITH BELZONA

ID: 4876

Customer Location: Luxury yacht builder, Holland
Application Date: December 2013

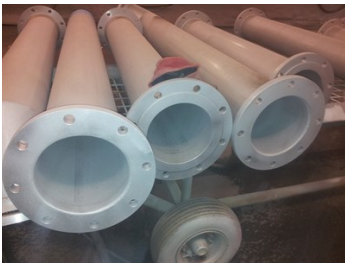
- * Exhaust sections following internal grit blasting ,
- * Internal pipe lining in progress using Belzona 1381 ,
- * Completed application ,
- * Close up of finished pipe end showing Belzona 1391T ,
