BELZONA SAFETY GRIP SYSTEM FOR ROOF ACCESS STAIRS

ID: 4887

Customer Location: Markham, Ontario, Canada
Application Date: December 2013

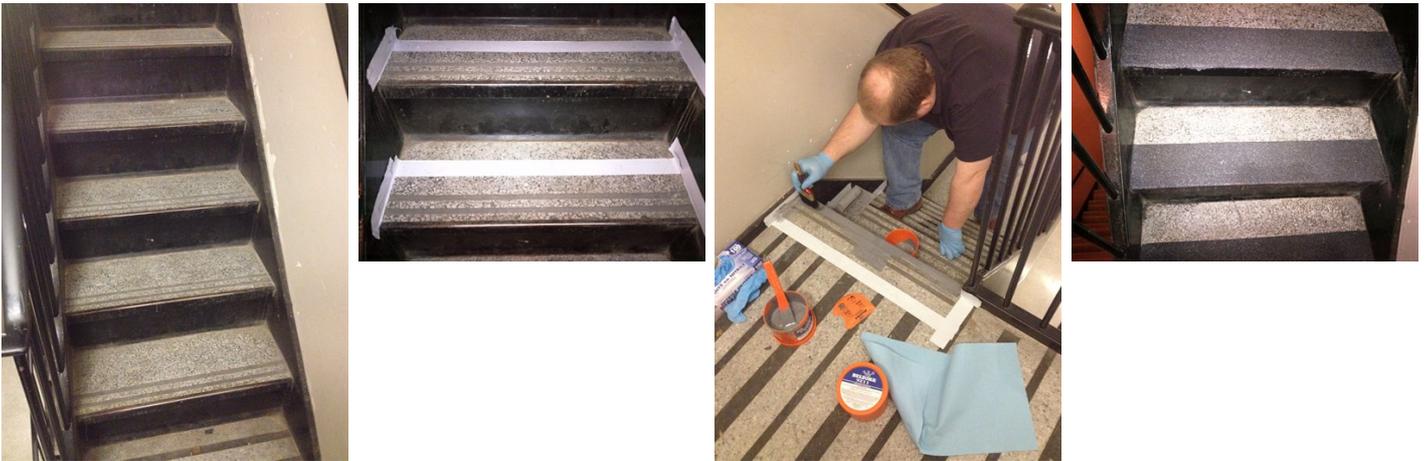
Extensive water and salt exposure had made it virtually impossible to maintain the Health and Safety requirements for any extended period of time.

- * Stairs prior to application ,
- * Preparation complete ,
- * Application in progress ,
- * Complete application ,

Application was carried out in accordance with Belzona Know-How System Leaflet FPA-8. Removed the existing adhesive tape and prepared the area ready for application. Belzona 4411 with Belzona 9211 was applied to eighteen steps and nosings.
