BELZONA SAFETY GRIP SYSTEM FOR ROOF ACCESS STAIRS

ID: 4887

Application: FPA-Floor Problem Areas

Substrate: Terrazzo flooring

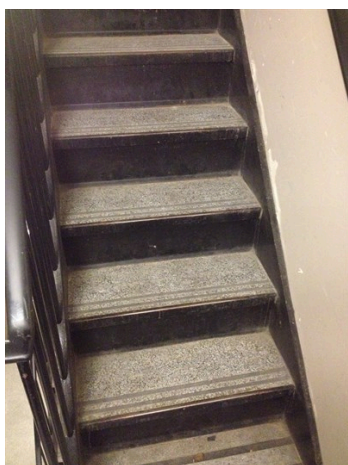
Extensive water and salt exposure had made it virtually impossible to maintain the Health and Safety requirements for any extended period of time.

- * Stairs prior to application ,
- * Preparation complete ,
- * Application in progress ,
- * Complete application ,

Application was carried out in accordance with Belzona Know-How System Leaflet FPA-8. Removed the existing adhesive tape and prepared the area ready for application. Belzona 4411 with Belzona 9211 was applied to eighteen steps and nosings.
