# BELZONA SUPPORTS WINTER MAINTENANCE SYSTEM

ID: 4888

Application: TCC-Tanks and Chemical Containment Areas

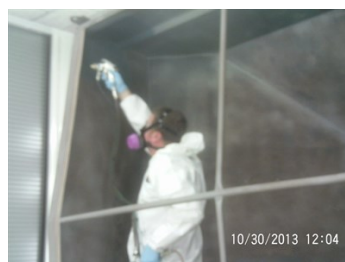
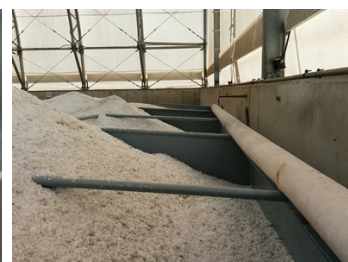
The internal walls of the salt hopper were suffering from corrosion and salt would not flow to the screw auger at the bottom.

- \* External view of salt hopper ,
- \* Salt hopper prior to application ,
- \* Application ,
- \* Completed application in service ,

The application was carried out in accordance with Belzona Know-How System Leaflet TCC-5. The surface was prepared by abrasive blasting and then two coats of Belzona 6111 were applied. Providing additional corrosion protection two coats of Belzona 5111 were applied.
