LOWER HALF OF KNOCK OUT VESSEL PROTECTED WITH BELZONA

ID: 489

Customer Location: Oil Refinery-Australia
Application Date: May 2004

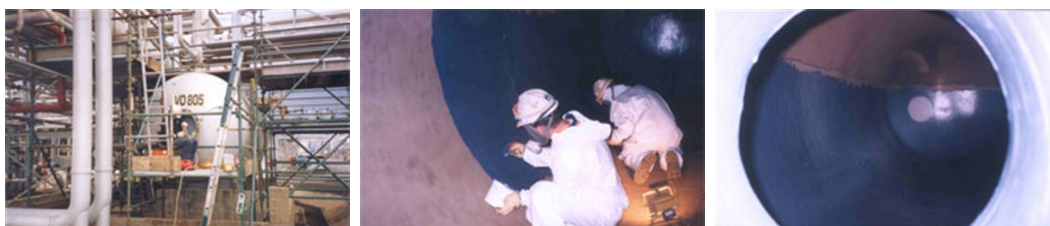
Photograph Descriptions

Internal erosion corrosion in lower section caused by sour water. Vessel regularly steamed out.

- * Typical limited access to vessel through manway ,
- * Application of Belzona® 1391 underway ,
- * Completed application ,

Application was carried out in accordance with Belzona Know-How System Leaflet TCC-5. Belzona® 1311 was used to repair pitting (particularly in 4-8 o'clock positions) and to smooth out weld repairs after which the lower half of the vessel was coated with Belzona® 1391.
