# BELZONA REPAIRS A SCREEN'S BASE

ID: 4890

**Customer Location:** Mine, MG, Brazil  
**Application Date:** May, 2011

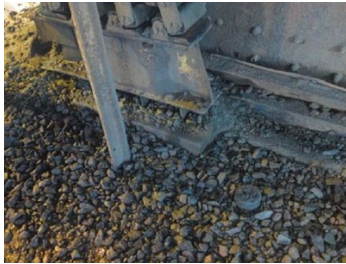
Excessive vibration generated wear and slack on the screen's concrete base, resulting in damaged anchor bolts.

- \* Screen's base ,
- \* Wood mold for the base ,
- \* Base with Belzona 4124 ,
- \* Application of Belzona 4111/4151. ,

The application was carried out based on Belzona Know-How System Leaflets TCC-9 and FPA-10. The concrete surface was prepared by mechanical scarification. Metallic surface was prepared using mechanical and manual tools according to application standards. After cleaning, the conditioner Belzona 4911 was applied on the concrete. Belzona 4124 was used to fill the base and Belzona 4111/4151 was injected to set the anchor bolts in place.
