BELZONA SETS ANCHOR AT THE GEARBOX BASE OF ROD MILL

ID: 4893

Application: FPA-Floor Problem Areas

Substrate: Reinforced Concrete

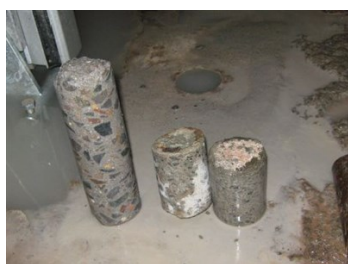
There was a need to install reinforcement at the anchoring of the concrete with base plate of the gearbox, with the addition of four extra intermediate anchors that could be set efficiently. Return to service needed to be as quick as possible as the damaged base was causing the equipment to break.

- * Damaged gearbox base causing excessive vibration ,
- * Base holes to anchor's housing ,
- * Anchors set according to template ,

There was a need to set intermediate anchors with a fast curing material with efficient anchorage on concrete base.

The application was carried out in accordance with Belzona Know-How System Leaflet FPA-10.

Belzona solution offered fast and efficient repair. Cure time was minimum, meeting client's expectations.
