# BELZONA RECOVERS BALL MILL'S BASE

ID: 4894

**Customer Location:** Aluminum Producer, MA, Brazil  
**Application Date:** August 2005

Ball mill engine and gearbox base

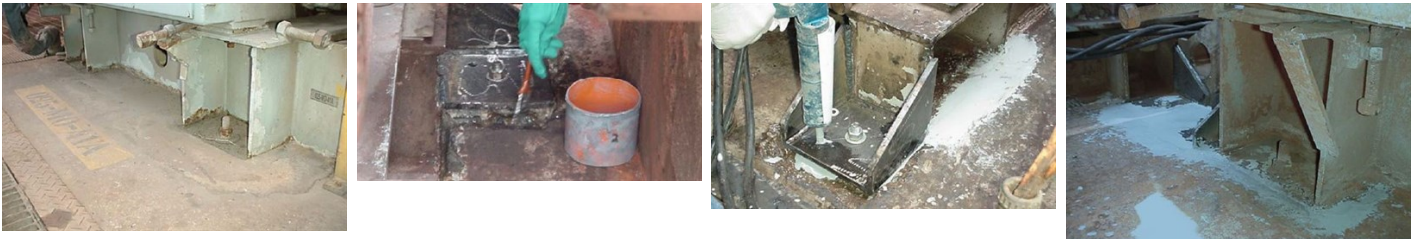
In an inspection conducted by the producer, it was found that there was a very high vibration caused by excessive gap at the base of the ball mill engine and gearbox. It was necessary to provide an effective solution for the situation not to worsen over time.

- \* Mill's base before product application ,
- \* Application of Belzona 4911 conditioner ,
- \* Product application by injection ,
- \* Base after application of Belzona 4111/4151 ,

This application was carried out based on Belzona Know-How System Leaflets FPA-10 and FPA-1. Surface was prepared through mechanical scarification. After cleaning, the surface was conditioned with Belzona 4911. After that, Belzona 4111 and Belzona 4151 were applied by injection technique. These products have excellent adhesion, vibration and compression resistance and are superior to conventional concrete in order to minimize the effects of wear (gaps) at the base of anchor bolts.

Following data was found through vibration analysis: Before application – average vibration of 10.57 mm/s<sup>2</sup>. After application –

average vibration of 3.38 mm/s<sup>2</sup>. Based on that, it was concluded that Belzona's technology reduced the vibration effects on the equipment by 1/3.
