# BELZONA REPAIRS THE BASE DRIVE OF A COKE MILL

Base drive of the ball mill

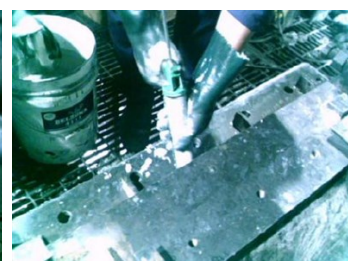
The leveling grout of the mill's base drive was crushed, cracked and had loss of a section. Because of that, the equipment lost partial support area, which increased the pressure on the horizontal and vertical load anchors. Consequently, anchors sheared over time, which increased the vibration of the equipment.

- \* Drive base crushed, cracked and with loss of a section ,
- \* Application of Belzona 4911 on all the surface of the base ,
- \* Base completely recovered with Belzona 4111 ,
- \* Application of Belzona 4111 and Belzona 4151 by injection ,

This application was carried out based on the Belzona Know How System Leaflets FPA-10 and FPA-1. First, all existing grouting was removed. The base surface was prepared with industrial sander and, after cleaning, conditioned with Belzona 4911 and Belzona 4111 was applied. After preparation, the metal structure was installed on the base and leveled with shims and anchor bolts. Application of Belzona 4111 and Belzona 4151 followed by injection. Operation conditions: temperature 30 to 40°C – Dry Service.

Belzona System allowed quick repair with the minimum downtime and avoided expensive structural reconstructions. Repair took 9 hours to complete. Vibration reduction: before application 19.69 mm/s, after application 1.98 mm/s.
