BELZONA APPLIES ANTICORROSIVE COATING ON A THICKENER

ID: 4896

Customer Location: *Mine, PA, Brazil*
Application Date: *January, 2012*

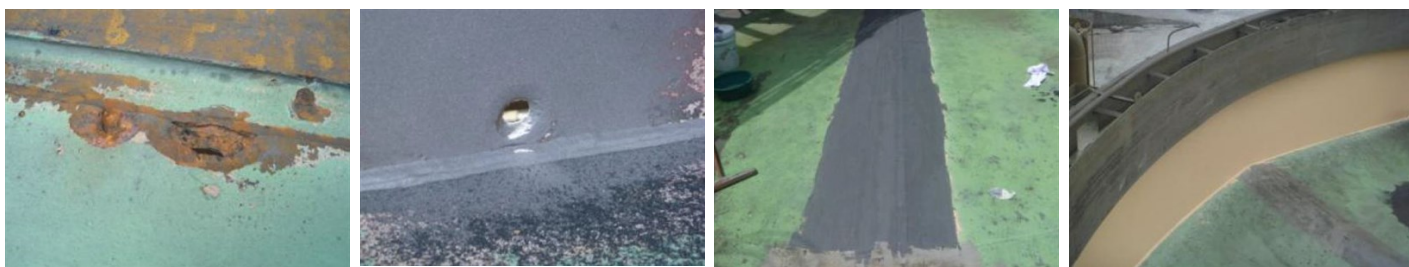
The wall area and the bottom of the thickener presented areas with localized corrosion, which needed thickness and internal lining repair. In addition protection of the steel plate against corrosion, caused by copper pulp at room temperature, was required.

- * Hole on the bottom of the thickener ,
- * Hole on the wall of the thickener ,
- * Supporting beam on the bottom of the thickener coated with Belzona 1321 ,
- * Wall coated with Belzona 5831 ,

The coating was applied on half of the internal area of the wall and on half of the support beams of the bottom of the thickener based on Belzona Know-How System Leaflets TCC-1 and TCC-5. First, the thickener was washed to remove the copper ore residues. Following the surface preparation, with dry abrasive blast to achieve near white metal finish, the holes, pits and existing welds were repaired with Belzona 1311. After that, Belzona 1321 was applied on the bottom of the thickener, and Belzona 5831 was applied on the wall.

The application was successful and Belzona 5831 offered excellent protection even when applied on damp surfaces
