BELZONA MAINTAINS CORRODED SPRINKLER TANK BY PLATE BONDING

Customer Location: Industrial Foam Manufacturer,
Northamptonshire UK

Application: TCC-Tanks and Chemical Containment
Areas

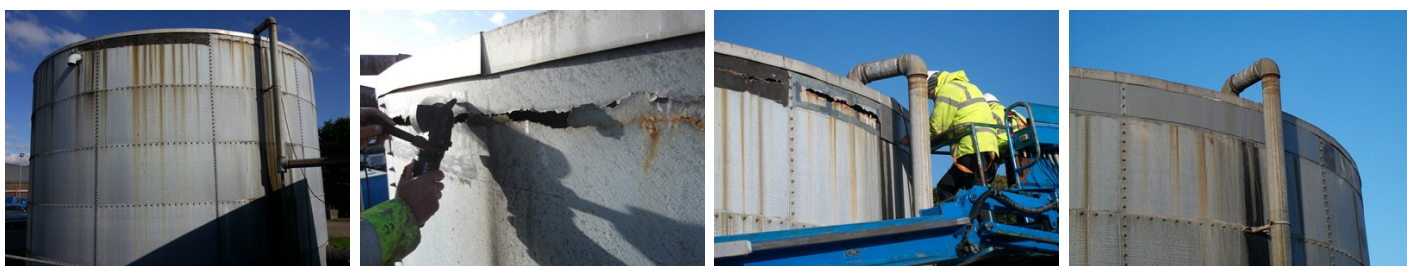
Photograph Descriptions

Over several years the tank had become badly corroded around approx. 50% of the circumference at the water line causing it to split open in some areas allowing water to flow out.

* 1. Large sprinkler tank with corrosion at water line 2. Surface being prepared with MBX Bristle Blaster 3. 400mm long x 300mm high steel plates being installed using Belzona 1161 4. Installation complete around tank circumference and coated with Belzona 5831 ,

Application was carried out in accordance with Belzona Know How System Leaflets TCC-1 and TCC-5. Doubler plates were bonded in place with Belzona 1161 before applying Belzona 5831 for overall corrosion protection.

For fire safety reasons the tank needed to be constantly on line, 24 hours a day, 7 days a week so replacing it with a new tank was not an option due to time and budget. Belzona repair completed with tank on-line.
