BELZONA RESTORES JAPANESE ALUMINUM END COVERS

ID: 49

Customer Location: *Paperboard Mill in Ontario, Canada*
Application Date: *September 1999*

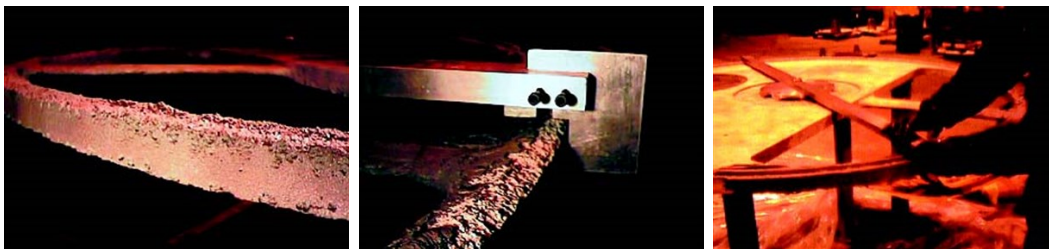
Photograph Descriptions

Severe erosion caused by a combination of corrosive environment and abrasion of a fanbelt.

- * The corroded end cover. ,
- * Work in progress. ,
- * The end cover repaired and ready for service. ,

Aluminum end covers from formers of Kobayashi paper machine. Six formers with two end covers per machine.

The application was carried out in accordance with a modified version of Belzona Know-How Leaflet GSS-10.
