BELZONA APPLIES POSITIVE GRIP SYSTEM ON DRIVE PULLEY

ID: 4915

Industry: *General Industry*
Application: *SHM-Solids Handling Machinery*

Customer Location: *Brechin, Ontario, Canada*
Application Date: *December 2012*

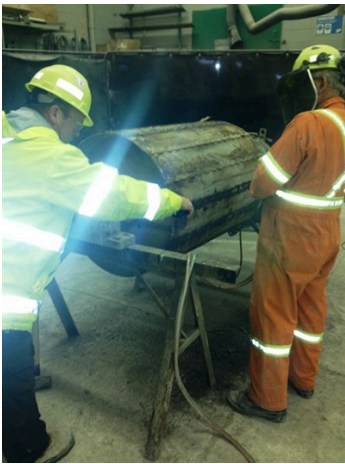
Existing steel lagging to create traction failed. This creates exposed edges which could possibly tear the belt.

- * Drive pulley prior to application ,
- * Preparation completed ,
- * Application in progress ,
- * Complete application ,
