# BELZONA APPLIES POSITIVE GRIP SYSTEM ON DRIVE PULLEY

ID: 4915

Industry: General Industry  
Application: SHM-Solids Handling Machinery

Customer Location: Brechin, Ontario, Canada  
Application Date: December 2012

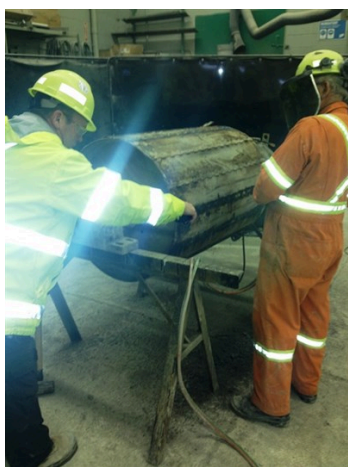
Existing steel lagging to create traction failed. This creates exposed edges which could possibly tear the belt.

- \* Drive pulley prior to application ,
- \* Preparation completed ,
- \* Application in progress ,
- \* Complete application ,

Application was carried out in accordance with Belzona Know-How System Leaflet SHM-12. The surface was prepared by initially grinding the steel to create a clean surface and then abraded with the MBX Bristle Blaster to create the correct surface profile. After surface preparation, duct tape was then applied to chevron pattern. Belzona 1821 was applied to the steel and Belzona 9211 was applied over the Belzona 1821 in accordance with the Belzona Instructions For Use.
