BELZONA ADDS LIFE TO ASH LINES

ID: 492

Application: SHM-Solids Handling Machinery

Customer Location: Power station in Macedonia

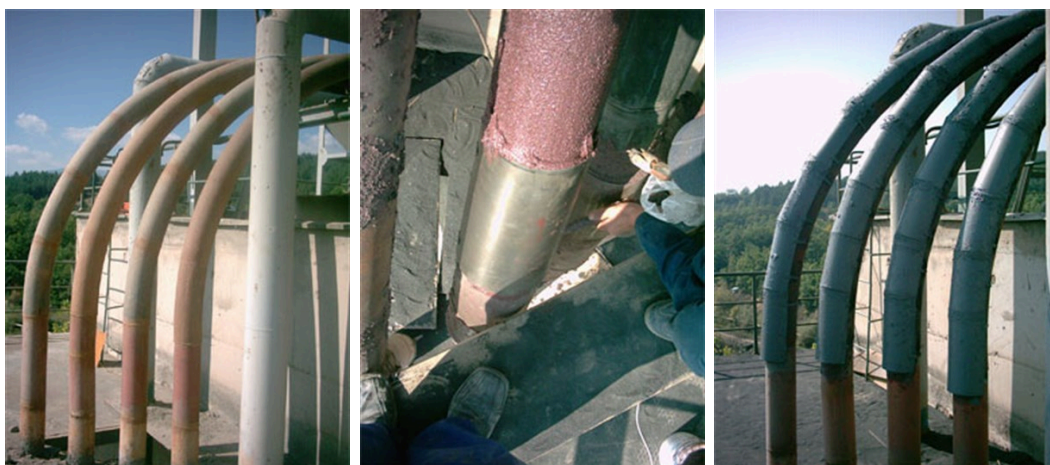
Photograph Descriptions

The pipes had worn thin through constant abrasion from the ash. Although not leaking, plant needed to extend life of the pipes before they failed.

- * The pipes before preparation ,
- * Belzona® 1811 being applied to pipe and patch ,
- * The completed application ,

Application was carried out in accordance with Belzona Know-How System Leaflet SHM-8. Metal patches were bonded in places where pipes were known to have worn thin.

Welding had been used on small leaks but Belzona® 1811 had proven more effective both in time for application and overall abrasion resistance. Clients confidence from previous applications with Belzona® 1811 led to it being used on these pipes.
