BELZONA ADDS LIFE TO ASH LINES

Industry: Power

Application: SHM-Solids Handling Machinery

Customer Location: Power station in Macedonia

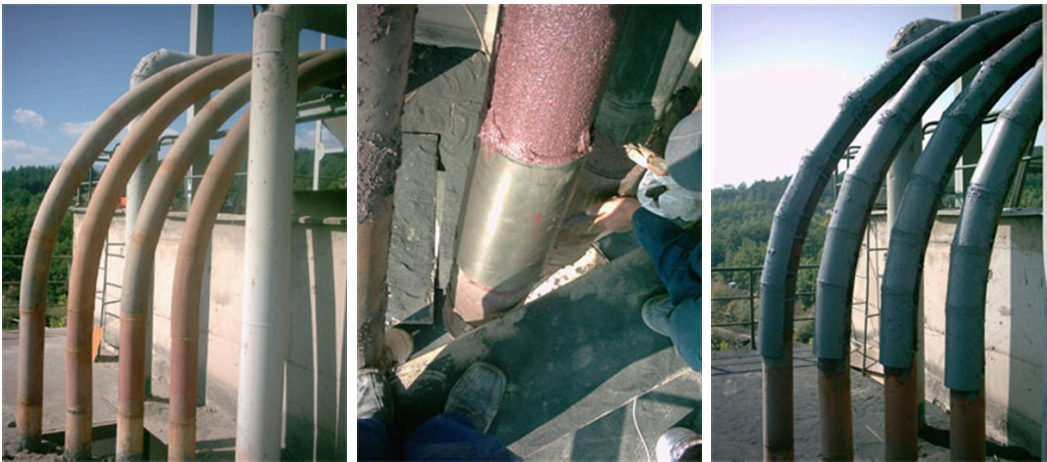
Photograph Descriptions

The pipes had worn thin through constant abrasion from the ash. Although not leaking, plant needed to extend life of the pipes before they failed.

- * The pipes before preparation ,
- * Belzona® 1811 being applied to pipe and patch ,
- * The completed application ,

Application was carried out in accordance with Belzona Know-How System Leaflet SHM-8. Metal patches were bonded in places where pipes were known to have worn thin.

Welding had been used on small leaks but Belzona® 1811 had proven more effective both in time for application and overall abrasion resistance. Clients confidence from previous applications with Belzona® 1811 led to it being used on these pipes.
