BELZONA PROTECTS ELECTROLYTE RECIRCULATION TANKS

ID: 4933

Customer Location: *Copper Mine, Arizona*
Application Date: *2011 - 2012*

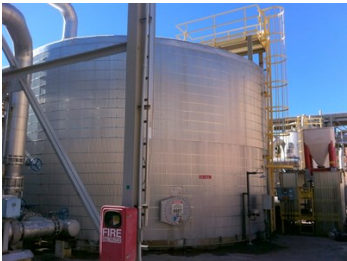
- * Overview of the electrolyte recirculation tank ,
- * Tank leaking and deteriorating the concrete containment area ,
- * Interior tank walls prior to coating ,
- * Interior tank walls following Belzona 4341 application ,

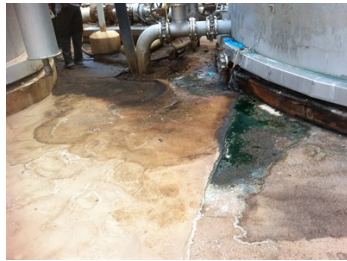
Electrolysis combined with chemical attack and metal fatigue were causing leaking at the weld seams of the tanks.

The tanks had been experiencing leakage for years with the subsequent loss of product/copper sulfate as well as the extreme damages which were taking place on the concrete containment area surrounding the tanks.
