# GARBAGE ROOM FLOOR REPAIR AND COATING AT A MALL

Application: FPA-Floor Problem Areas

Substrate: Concrete

Products: \* Belzona 4131 (Magma-Screed) Belzona 5231 (SG Laminate) ,

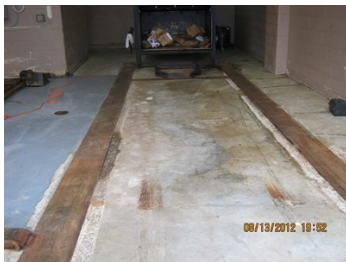
A combination of waste causing chemical attack and physical damage caused by large roll on, roll off containers.

\* 1.Flooring prior to application 2.Application in progress 3.Complete application 4.Eighteen months after application ,

Application was carried out in accordance with Belzona Know-How System Leaflet FPA-1. The surface was prepared by removing any existing coating and loose material or contamination and abraded to expose the aggregate. Belzona 4131 was applied to rebuild and repair the damaged concrete. Belzona 5231 was applied to the garbage room floor with a roller in accordance with Belzona Instructions For Use.

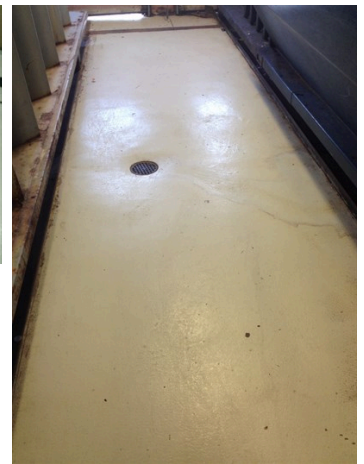
The repairs and coating provide resistance to the daily activities, wear and attack. Eighteen months after application (March 2014) the system is performing excellent.
