# BELZONA REPAIRS GLASS LINED REACTOR

ID: 4940

Industry: Chemical & Petrochemical  
Application: TCC-Tanks and Chemical Containment Areas

Customer Location: Chemical Plant, Israel  
Application Date: 2009

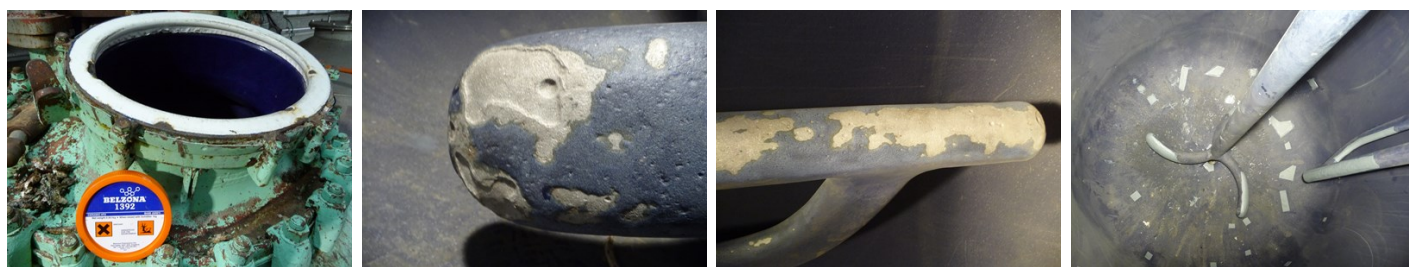
*Due to the operational environment the glass lining in the reactor and on the agitator paddle was severely damaged exposing the base metal to severe corrosion.*

- \* The reactor ,
- \* Damage on the paddle ,
- \* Reactor damage ,
- \* Completed reactor repairs ,

Due to the extent of damage, especially on the paddle area, no other repairs alternative was available. The only option was replacing the reactor with new unit. The Belzona solution was completed on site and the unit was back to service in two days. The unit was inspected in 2012 and apart from slight erosion on the paddle was found in excellent condition.
