# BELZONA PROTECTS LIKE NO OTHER

ID: 497

Customer Location: Chemical manufacturing company,  
Florida - USA

Application: FPA-Floor Problem Areas

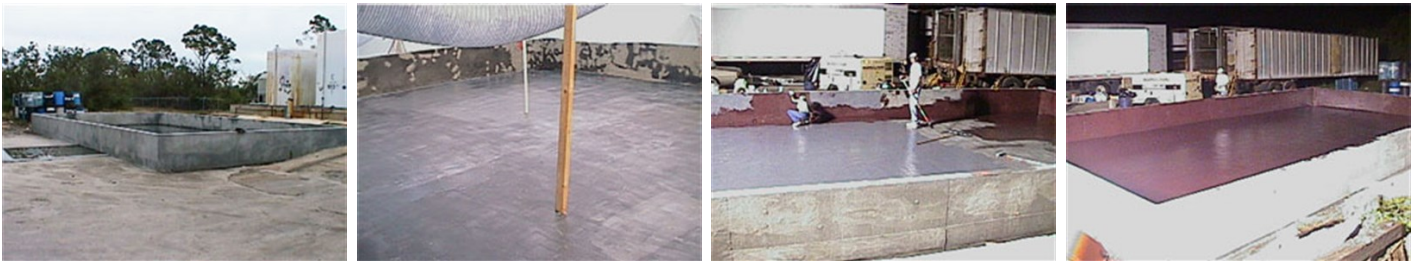
## Photograph Descriptions

Old containment's rubber liner had failed from use and UV damage. Protection of new containment was required for continued use of acid mix down plant.

- \* General view of the area ,
- \* Belzona® 4911 and Belzona® 4141 applied ,
- \* Belzona® 4311 coat interrupted ,
- \* Belzona® 4311 applied over night, completing the application ,

Protect new containment for concentrated acid storage tanks

Application was carried out in accordance with Belzona Know-How System Leaflets FPA-3 and TCC-15.
