BELZONA USED IN MAJOR REFURBISHMENT OF 75-YEAR-OLD DAIRY

Customer Location: Dairy, Gloucestershire

Application: FPA-Floor Problem Areas

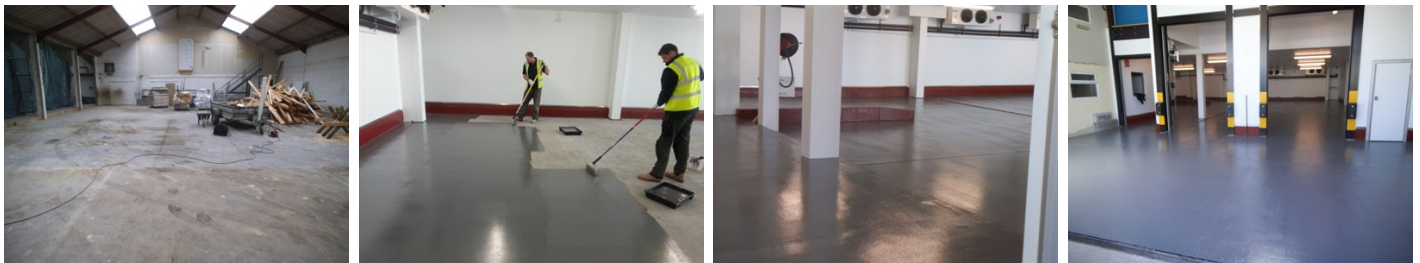
Photograph Descriptions

- * Disused warehouse before application ,
- * During application of Belzona 5231 ,
- * & 4. Completed application ,

Application was carried out in accordance with Belzona System Leaflets FPA-1, FPA-3, FPA-11 and WPA-4. A slurry mix of Belzona 4111 was used to bond on the kerbstones. Belzona 4131 was used to repair several areas of concrete floor damage. The floor and kerbstones were coated with Belzona 5231. Belzona 4141 was used to repair damage to the vertical concrete columns.
