BELZONA REBUILDS ERODED STERN TUBE SEALING FACE

ID: 4973

Customer Location: *Maersk Lines Container Ship, Lisnave
ShipYard, Setubal, Portugal*

Application: *SOS-Ships and Offshore Structures*

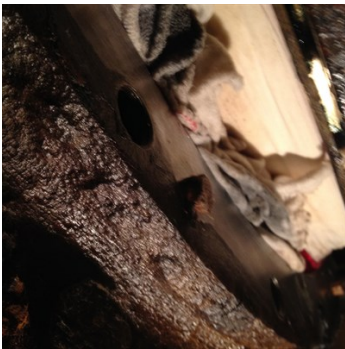
Galvanic corrosion damage on the boss sealing surface of stern tube system

- * Stern Tube with Galvanic Corrosion ,
- * Stern Tube after preparation with MBX Bristle Blaster ,
- * Stern Tube after applying Belzona 1311 ,
- * Completed repair after polishing the Belzona 1311 ,
