Standing Water - Not A Problem With Belzona

Industry: General Industry
Application: RPA-Roof Problem Areas
Substrate: Stainless Steel
Products: * Belzona® 3111 (Flexible Membrane) ,
* Belzona® 3921 (GSC Surface Conditioner) ,
* Belzona® 9311 (Membrane Reinforcing Sheet) ,

Customer Location: Air Force Base, Texas - USA
Application Date: March 2005

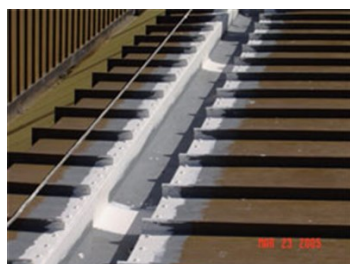
- * Gutters conditioned with Belzona® 3921 and seams coated with Belzona® 3111. ,
- * Seams coated with Belzona® 3111. ,
- * First coat of Belzona® 3111. ,
- * Second coat of Belzona® 3111. ,
