BELZONA WAREHOUSE FLOOR

Industry: Chemical & Petrochemical
Application: FPA-Floor Problem Areas
Substrate: Concrete
Products: * Belzona® 4131 (Magma screed) ,

Customer Location: Chemical plant in Louisiana
Application Date: April 1995

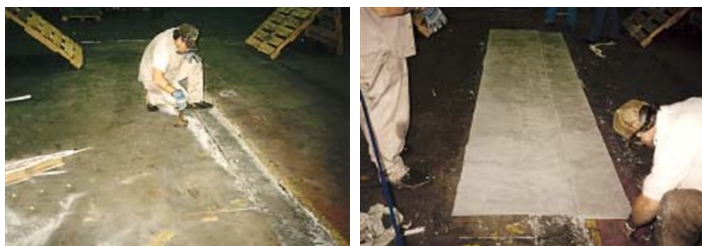
Deteriorated floor was creating a safety hazard.

- * Surface preparation to the damaged area in progress. ,
- * The completed repair. ,

The application was carried out in accordance Belzona Know-How Leaflet FPA-1.

This is a long term solution to the problem. After three years in operation, the floor is in excellent condition.
