# BELZONA REPAIRS CHIPS FROM THE OLD BLOCK

Customer Location: *Lumber mill in Northern Ontario, Canada*

Application: *SHM-Solids Handling Machinery*

Chip cyclone

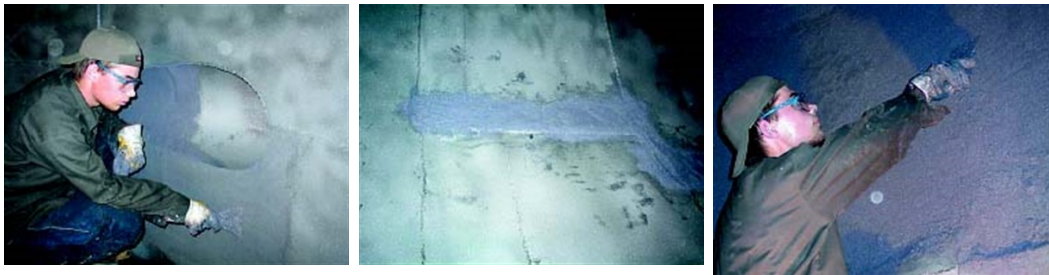
## Photograph Descriptions

*The cyclone's steel substrate was worn by continuous abrasion from wood chips entering at high velocity.*

- \* Prepared substrate and Belzona® 1812 application to chip chute ,
- \* Belzona® 1812 being applied to the seams ,
- \* Belzona® 1812 being applied to the mid-section ,

The application was carried out in accordance with Belzona Know-How System Leaflets SHM-13, FBC-5 and TCC-1.
