# Belzona for Cooling Tower Basins - Even in Cold Weather

Application: TCC-Tanks and Chemical Containment  
Areas

Cooling tower basin

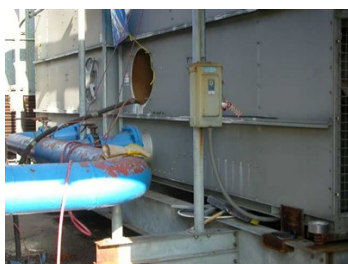
- \* Side of tower, showing opening ,
- \* Interior, corroded ,
- \* First coat of Belzona® 5811 ,
- \* Final coat of Belzona® 5811 - ready for service ,

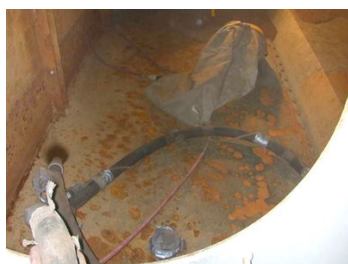
Lack of protective coating allowed for leaks to develop.

After postponing repairs for 4-5 years, the basin was leaking enough to force the issue. After surface preparation by grit blasting, there were many pin holes, but all were too small to allow the Belzona® 5811 to leak through so an impervious surface was achieved. Two cooling tower basins were protected in cold weather by placing heaters below the basin, and a tarpaulin across the top, so raising the interior temperature to 65°F (18°C).
