Belzona for Cooling Tower Basins - Even in Cold Weather

ID: 500

Application: *TCC-Tanks and Chemical Containment
Areas*

Cooling tower basin

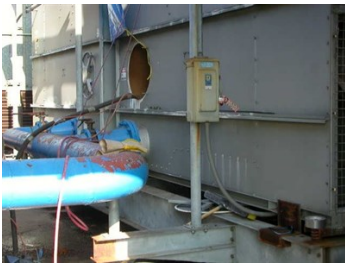
Lack of protective coating allowed for leaks to develop.

- * Side of tower, showing opening ,
- * Interior, corroded ,
- * First coat of Belzona® 5811 ,
- * Final coat of Belzona® 5811 - ready for service ,
