Belzona Flexible Membrane Keeps Turbine Room and Control Room Dry

ID: 501

Customer Location: *Power Cooperative, Texas, U.S.A.*

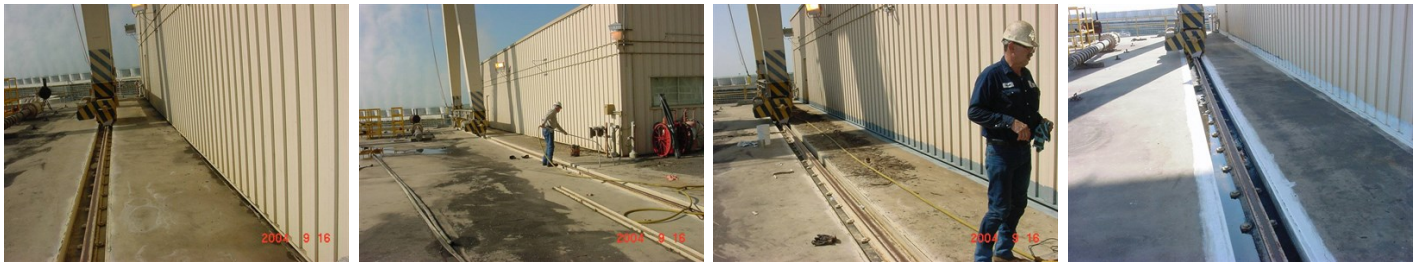
Photograph Descriptions

Water ingress to control room through walls and into turbine room via failed sealants.

- * Overview of control room wall area and crane track ,
- * Cleaning out old sealant and failed imitator products ,
- * Belzona® 3921 (GSC Surface Conditioner) applied ,
- * Completed repair ,

Application was carried out in accordance with Belzona Know-How System Leaflets RPA-1 & WPA-1.

Customer needed cost effective way to stop rain water intrusion into vital operating areas. Worn out sealants on turbine room roof and control room walls allowed wind driven rain to enter these critical areas. Repair needed to be customized to fit unusual shape.
