Severe Corrosion stopped with Belzona 3111 (Flexible Membrane)

ID: 502

Industry: Water / Wastewater
Application: RPA-Roof Problem Areas
Substrate: Steel

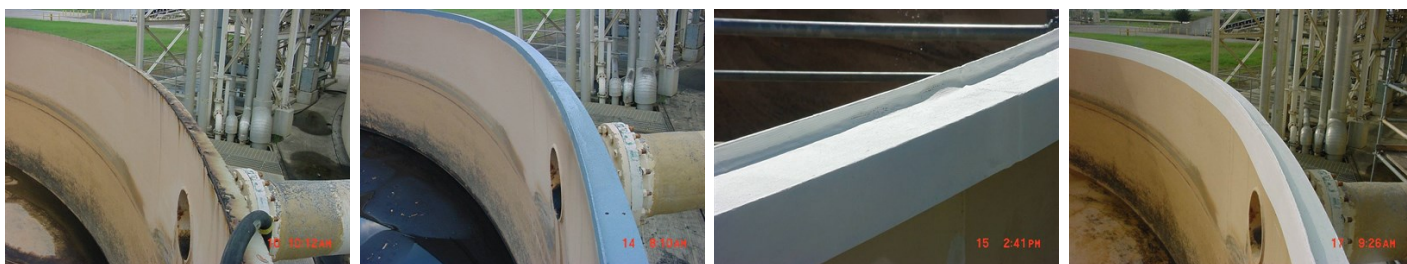
Photograph Descriptions

Severe corrosion caused paint delamination on top of exposed reclaim tank walls.

- * 1. The corroded reclaim tank wall. ,
- * 2. Surface prepared and conditioned with Belzona 3921. ,
- * 3. First coat of Belzona 3111. ,
- * 4. Top coat of Belzona 3111 applied. ,

Application was carried out in accordance with a modified version of Belzona® Know-How System Leaflet RPA-10.

Belzona 3111 (Flexible Membrane) has been successfully used in other parts of plant. Repeated painting and repainting did not provide long term relief. Areas were grit blasted to remove old paint and other products which had failed.
