BELZONA 9811 EXTENDS SERVICE LIFE OF FLOP GATE AT CEMENT PLANT

ID: 5024

Customer Location: *Bagged Concrete Plant, Virginia, USA*
Application Date: *October 2006*

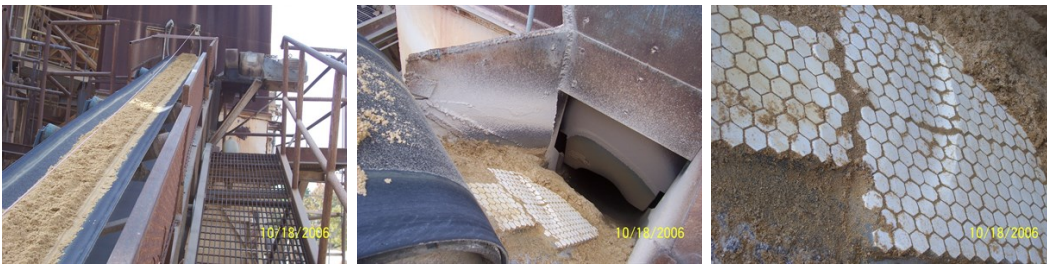
Photograph Descriptions

Excessive wear on the flop gate (valve) made of AR steel (AR 400). It only lasted 9 months before wearing out. Customer was looking for a longer term solution.

- * Quickcrete mixture on the conveyor belt ,
- * Flop gate repair completed ,
- * Flop gate repair close up ,

Application was carried out in accordance with Belzona System Leaflet SHM-7.

Customer was looking for an 18 month life cycle rather than the 9 months provided by AR 400. The first option, Belzona 1811 (Ceramic Carbide) lasted about 9 months, equivalent to the AR 400 steel. Belzona 9811 tiles solution has been in place since the fall of 2006.
