# BELZONA 9811 EXTENDS SERVICE LIFE OF FLOP GATE AT CEMENT PLANT

ID: 5024

Application: SHM-Solids Handling Machinery

Customer Location: Bagged Concrete Plant, Virginia, USA

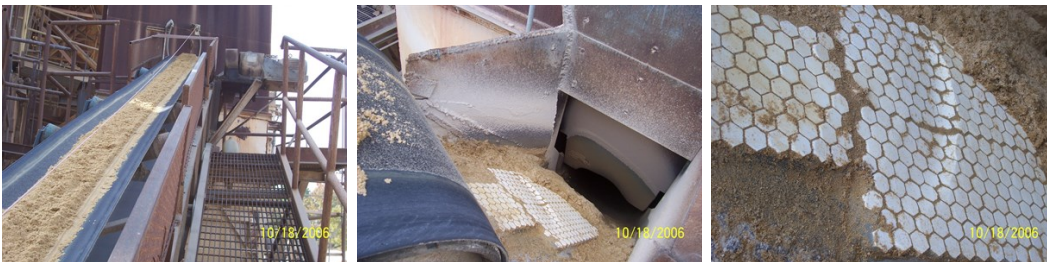
## Photograph Descriptions

Excessive wear on the flop gate (valve) made of AR steel (AR 400). It only lasted 9 months before wearing out. Customer was looking for a longer term solution.

- \* Quickcrete mixture on the conveyor belt ,
- \* Flop gate repair completed ,
- \* Flop gate repair close up ,

A flop gate which is a chute that is “flopped” to one side or the other exposing the chute that the plant needs the aggregate in.

Application was carried out in accordance with Belzona System Leaflet SHM-7.

Customer was looking for an 18 month life cycle rather than the 9 months provided by AR 400. The first option, Belzona 1811 (Ceramic Carbide) lasted about 9 months, equivalent to the AR 400 steel. Belzona 9811 tiles solution has been in place since the fall of 2006.
