Belzona® 2111 (D&A Hi Build Elastomer) Saves Utility

Industry: Power
Application: TCC-Tanks and Chemical Containment Areas
Substrate: Rubber
Products: * Belzona® 2111 (D&A Hi Build Elastomer) ,
* Belzona® 2911 (QD Conditioner) ,

Customer Location: Power Authority, San Antonio, Texas USA
Application Date: 2002

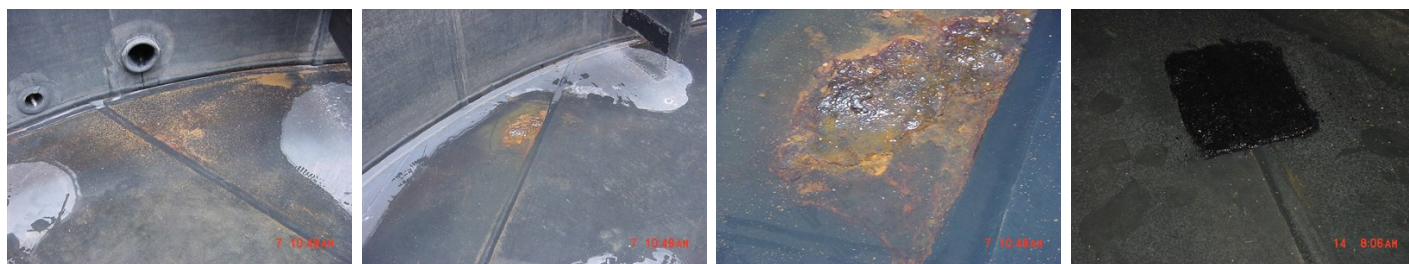
Photograph Descriptions

Inspection revealed severe corrosion in spots on floor. Customer needed fast, cost effective repair.

- * Lime slurry tank showing corrosion in rubber liner ,
- * Another view of corrosion ,
- * Close up view of corrosion ,
- * Belzona® 2111 patch complete ,

Rubber lined lime slurry tank

Application was carried out in accordance with Belzona Know-How System Leaflet TCC-3.

Hot vulcanization and liner replacement had been considered but were judged too time consuming and costly. Belzona® 2111 was chosen for its great abrasion and chemical resistance, as well as its ease of application. Repair still in excellent condition after three years of service.
