# BELZONA COLD PLATE BONDING ON BULK FUEL HOLDING TANK

**Customer Location:** Fuel Distribution Terminal, South Wales  
UK

**Application:** TCC-Tanks and Chemical Containment  
Areas

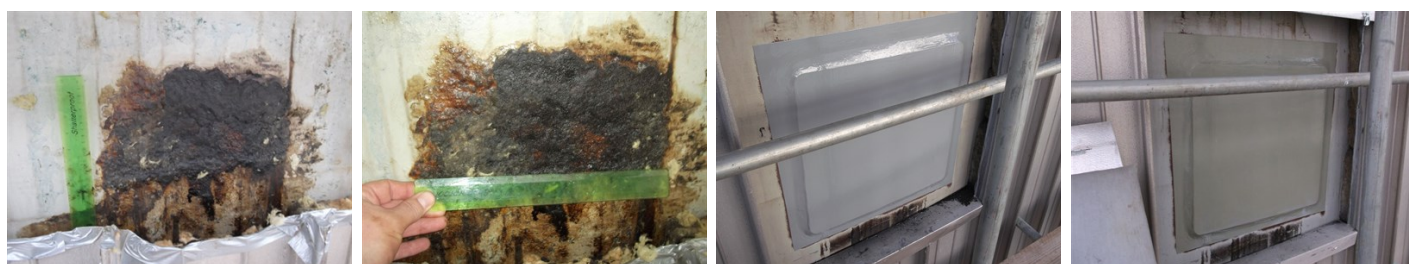
- \* 1 & 2. Original side wall tank hole/leak area ,
- \* 3. Completed application February 2013 ,
- \* 4. Application checked April 2014 ,

Insulated bulk holding tank containing heavy fuel oil. Corrosion under insulation had led to a through wall penetration at approximately 8m above ground level.

Due to the urgency, Belzona were quickly mobilised and prepared the substrates by grit blasting to the desired standard, bonding a 500x500x5mm plate using Belzona 1161 and final two coat system Belzona 5811 in accordance with Belzona System leaflet TCC-3.

In accepting the Belzona cost effective, safe cold bonding solution, the client duly received the fuel shipment and recharged the bulk holding tank without any fault from the application. This saved the client many thousands of pounds in delaying a sea shipment at port side. The application continues to be regularly monitored without any indication of deterioration or need to be
