# BELZONA® Macht poröses Mauerwerk wetterfest

ID: 5084

Industrie: Gebäude & Strukturen  
Anwendung: Wandproblembereiche  
Substrat: Sandstein  
Produkte: \* Belzona® 5122 (Clear Cladding Concentrate),

Standort des Kunden: Privathaus, Manchester, England  
Antragsdatum: August 2007

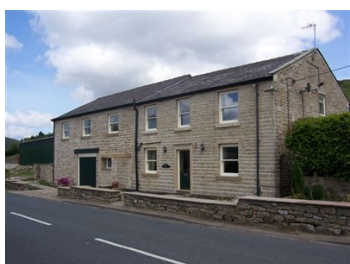
- \* Ansicht der Immobilie ,
- \* Abgeklebte Fenster und fertig zum Beschichten ,
- \* Belzona® 5122 mit Spritzeinheit ,
- \* Während der Anwendung ,
