# BELZONA REPAIRS CRUSHER'S ADJUSTMENT RING

ID: 5087

Industry: Mining & Quarrying

Application Date: February 2006

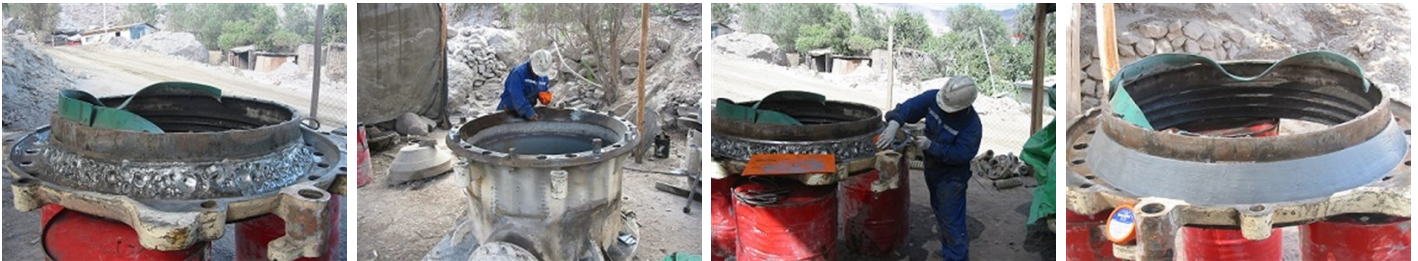
*The worn-out strip prevented the crusher from functioning well.*

- \* Damage on the ring of the crusher ,
- \* Application of Belzona 9411 on the surface of the crusher ,
- \* Application of Belzona 1111 on the strip of the worn-out ring ,
- \* The ring repaired with Belzona 1111 ,

Repair of the ring strip during an emergency stop.

First, the surface was prepared with emery cloth. Afterwards, Belzona 9411 was applied to the surface of the crusher in order to later apply Belzona 1111 to the worn-out ring and join the pieces together to mold Belzona 1111 between the two pieces.

The mine did not have another ring to replace the damaged one and was not able to stop the operations. The application of Belzona 1111 and Belzona 9411 solved the problem and enabled the crusher to continue working until the new ring arrived.
