# BELZONA REPAIRS AND PROTECTS CENTRIFUGAL PUMP HOUSING IN AN INDUSTRIAL MINE

ID: 5088

Customer Location: *Gold Extraction Mine, Guatemala*  
Application Date: *December 2006*

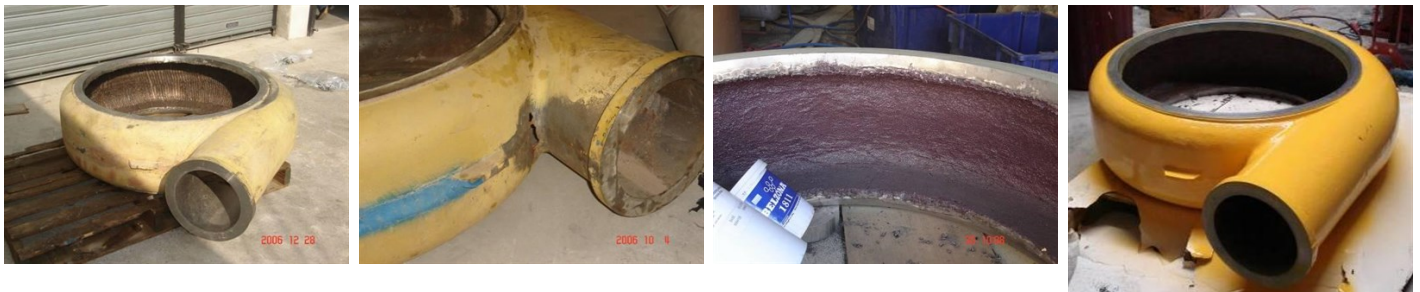
*Due to the severe abrasive conditions caused by the suspended solids, the pump casing was severely stripped and holes appeared in the housing.*

- \* Centrifugal pump housing ,
- \* Holes due to severe abrasion ,
- \* Application of the lining ,
- \* Application completed ,

Reconstruction and abrasion-resistant lining of the pump housing of the mud conveyor.

The preparation of the surface was done using a sand blasting method. The application was carried out in accordance with SSPC-SP 10 and Belzona System Leaflet SHM-11.
