# BELZONA RESTORES VACUUM PUMP AFFECTED BY DEEP EROSION

**Industry:** Mining & Quarrying  
**Application:** CEP-Centrifugal Pumps  
**Substrate:** Cast iron  
**Products:** \* Belzona 1311 (Ceramic R-Metal) ,  
\* Belzona 1341 (Supermetalgilde) ,

**Customer Location:** Mine, Peru  
**Application Date:** April 2008

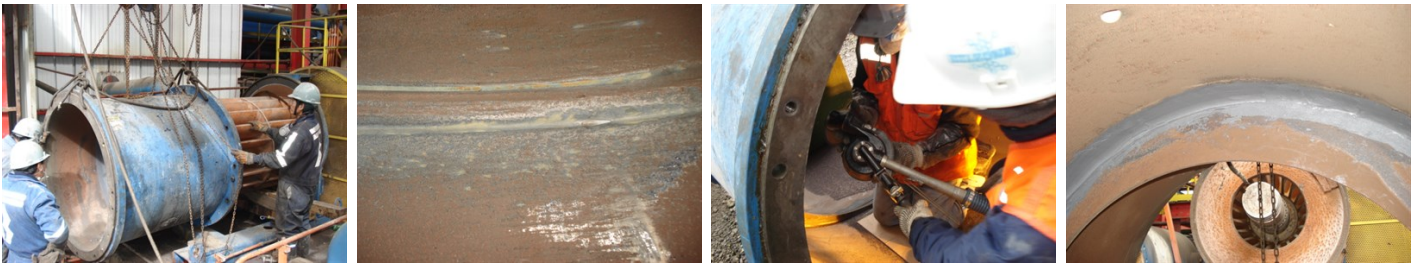
## Photograph Descriptions

Seal water drags solids deeply eroding the central body all around, on both sides of the central ribbing weakening the casing and even making a hole at one point.

- \* Disassembly of components ,
- \* Grooves caused by erosion all around on both sides ,
- \* Refilled with Belzona 1311 ,
- \* Reconstructed area was later covered with Belzona 1341. ,

The application was carried out in accordance with the Belzona Know-How System Leaflet CEP-5. It was locally blasted and filled in using Belzona 1311 and was covered with Belzona 1341.
