# BELZONA RECONSTRUCTS TURBINE BLADES AND IMPELLER

ID: 5091

Customer Location: Mine, Chile  
Application Date: July 2010

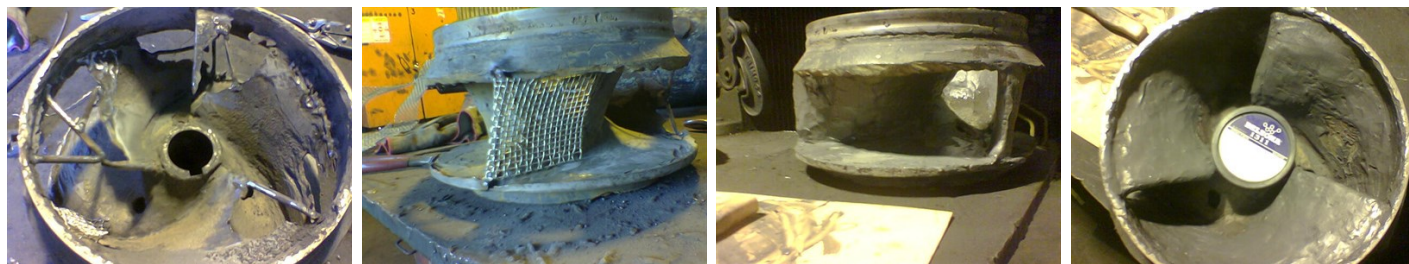
*The worn-out turbine blades prevented the equipment from working properly.*

- \* Original conditions of the impeller. The damage is observed as well as the welded bars. ,
- \* A wire mesh is placed to create the body of the turbine blades. ,
- \* Belzona 1311 was applied to the impeller ,
- \* Application completed. ,

The impeller was cleaned and the turbine blades were repaired to its original dimensions. In order to achieve this, bars were welded to define the area and provide support. Then, a wire mesh was placed with the goal to strengthen the repair and define the body of the turbine blades, in order to later apply Belzona 1311. Application was carried out in accordance with a modified version of Belzona Know-How System Leaflet CEP-1.
