# BELZONA REPAIRS THE GRIP OF A CONVEYOR PULLEY

ID: 5093

Customer Location: *Mine, Chile*  
Application Date: *August 2005*

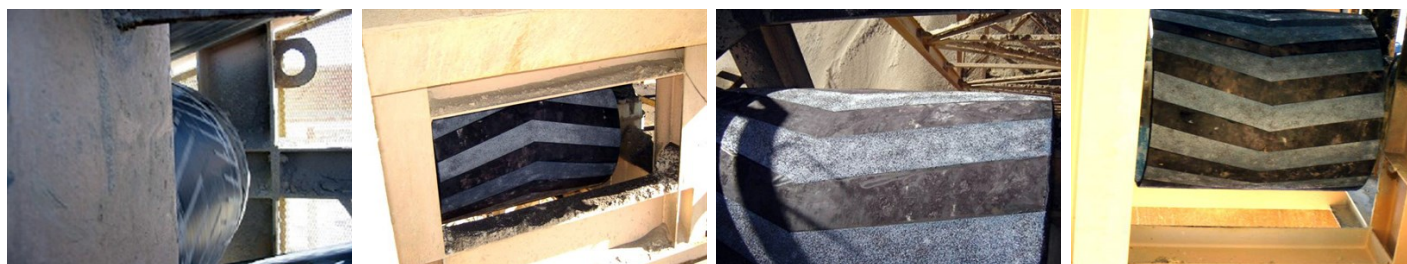
*Due to moisture problems, the conveyor belt slipped from the pulley, burning the coating, which led to loss of grip.*

- \* Damaged pulley ,
- \* Drawings on the pulley, applying Belzona 1321 and Belzona 9211 ,
- \* Pulley coated with Belzona 1321 and Belzona 9211 ,
- \* Application completed ,

The areas where the application was to take place had been marked in a chevron pattern. To achieve this, a gummed paper was used and then the surface was prepared, in order to obtain the highest roughness possible to start application of Belzona 1321 and Belzona 9211 products. Application carried out in accordance with Belzona Know-How System Leaflet SHM-12.

Emergency problem was solved without stopping the machine for maintenance, as requested by management. The repair was completed in maximum four hours.
