CORRODED AND CRACKED PIPEWORK FIXED WITH BELZONA

ID: 5106

Customer Location: *Manufacturing company, Slough, UK*
Application Date: *May 2014*

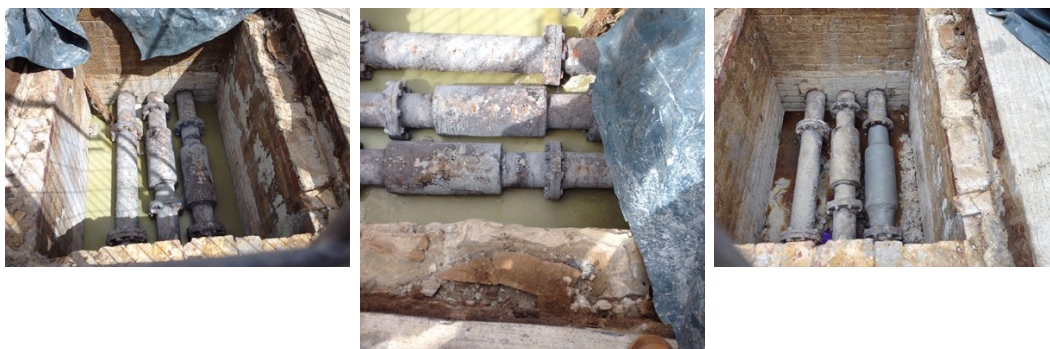
The pipe had corroded and cracked, leaking 10% Sodium Hydroxide.

- * 1&2. Cracked and corroded pipework ,
- * 3. Completed application ,

Application was carried out in accordance with Belzona System Leaflet VPF-11. Surface preparation was carried out using an MBX Bristle Blaster as grit blasting was not an option. After stemming weep, the pipe was wrapped with Belzona 1161 incorporating Belzona 9341 (Reinforcement Tape).
